Worldwide repairs carried out with PolymerMetal®

REP-# 090

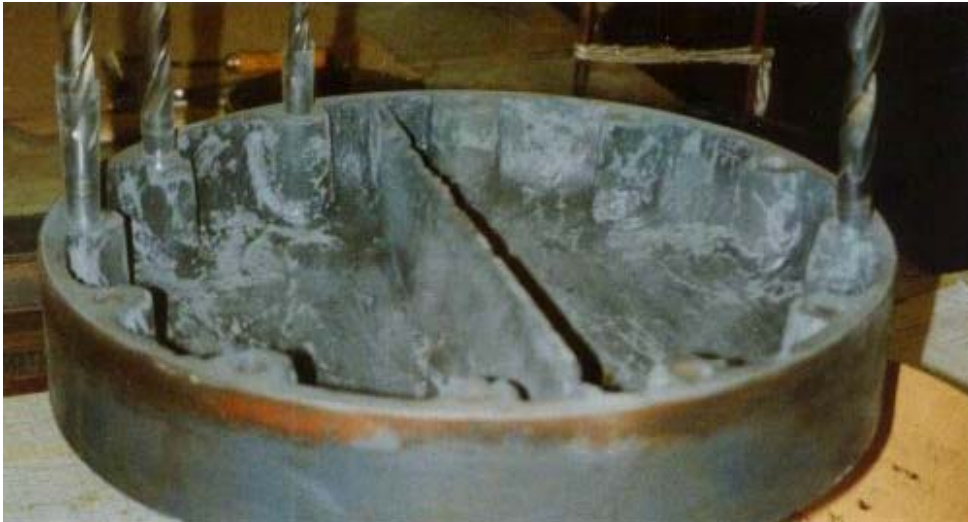
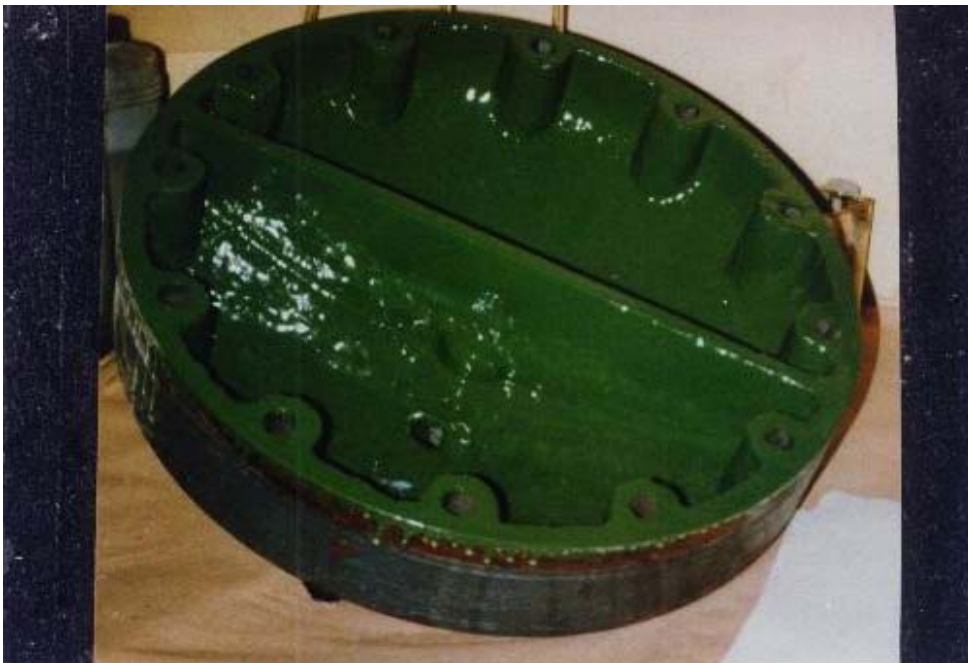
A cover with Ceramium was reconstructed. The coating was affected in two working procedures: First a surface reconstruction with Ceramium, pasty and Hardener CE. Second an application with Ceramium, liquid with Hardener CE.
