Worldwide repairs carried out with PolymerMetal®

REP-# 108

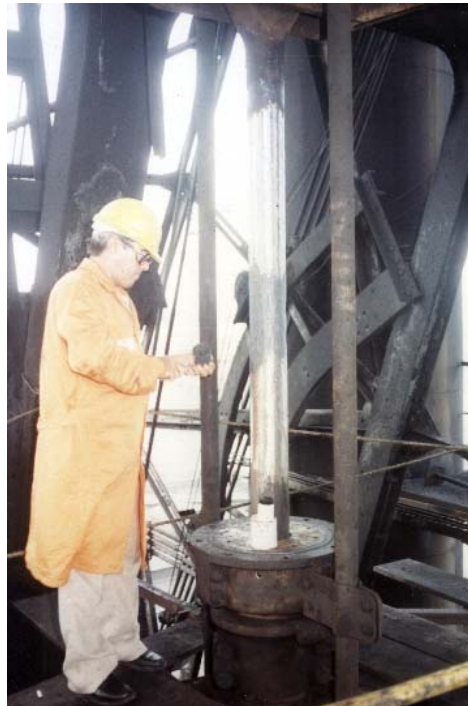
Repair of worn piston rods caused by the exhausts of a blast furnace. The piston rods were brought to nominal diameter again using Ceramium. After the repair has been completed the piston rods are in operation again over 3 years.
