## Worldwide repairs carried out with PolymerMetall®

REP-# 172

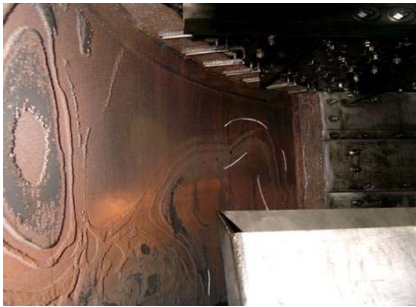
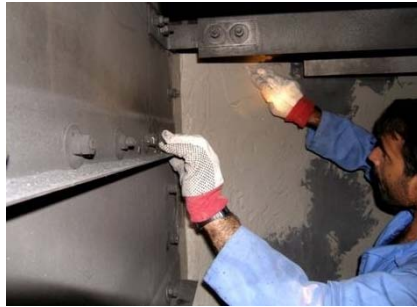
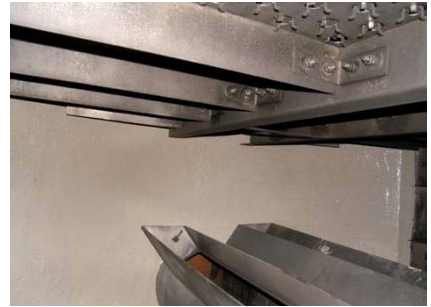
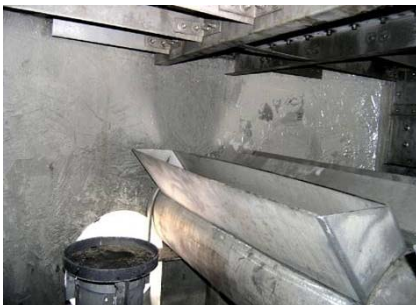
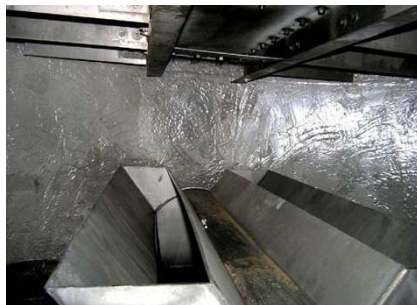
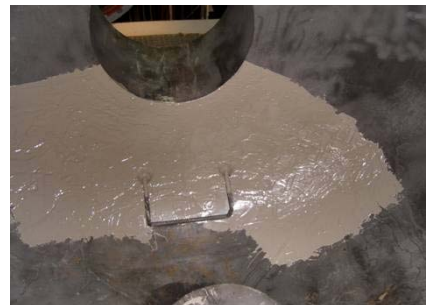
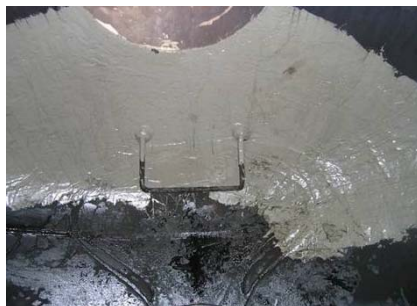
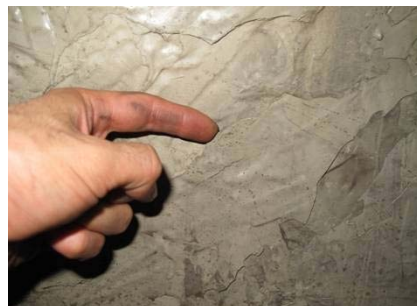
A refinery's gas washer for cleaning sour natural gas suffered from hard exposures and had massive corrosion damages in several areas. There appear high temperatures (140 °C), pressure (3 bar) and a line of chemicals (Amines MDEA, H<sub>2</sub>S, CO<sub>2</sub>, O<sub>2</sub>, various acids, ...). With MultiMetall's coating material Ceramium® CH / Hardener CH1 excellent results were achieved. Further details can be found here
